Name Of Dam: MIDDLETON DAM  
Location: LEE COUNTY, VIRGINIA  
Inventory Number: VA. NO. 10501

# PHASE I INSPECTION REPORT

## NATIONAL DAM SAFETY PROGRAM

Name of Dam: Middleton Dam      Va. No. 10501  
State: Virginia  
County: Lee  
USGS Quad Sheet: Pennington Gap  
Coordinates: Lat 36° 45.5'    Long 83° 06.9'  
Stream: Bowman Hollow  
Date of Inspection: May 23, 1979

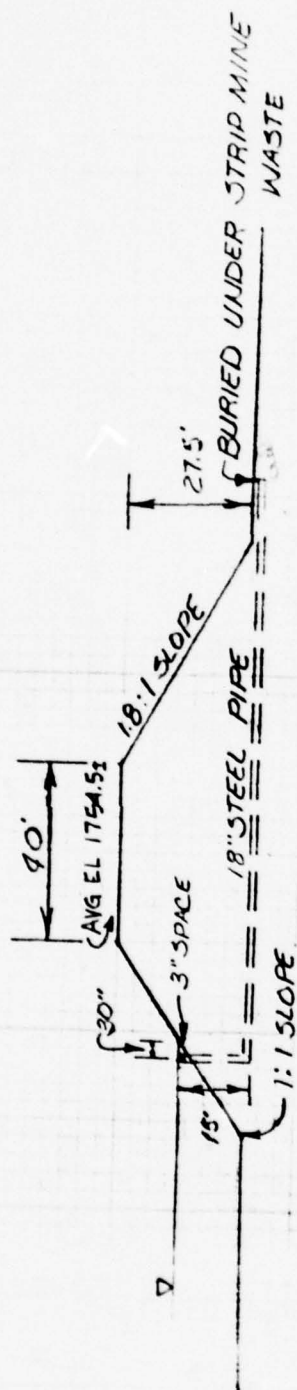
PLATE 3

The emergency spillway is a rock channel with a bottom width of 14 ft and a crest elevation of 1740.3 M.S.L. The emergency spillway is located on the right end of the dam with side slopes of about 1:1 and 2:1 (See Plate 3, Appendix I). The left side of the emergency spillway is on a 2:1 slope and is in a fill section. The right side of the emergency spillway is in a cut section of a 1:1 slope.
